Manhole Inspection Summary

Manhole # S21K1_010MH

Insp Date: **4/24/08 9:22 AM**

Location Address: **2931 stranden rd**

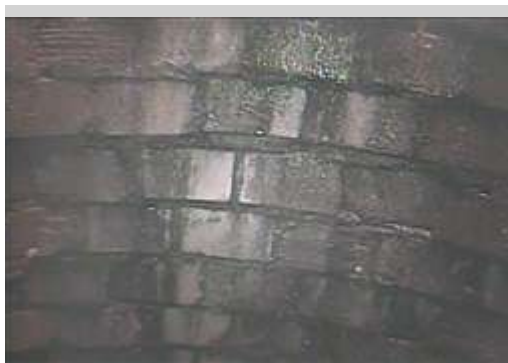
Defect 5

Infiltration: ☐ None ☐ Joint ☐ Cracks ☐ Mortar ☐ Roots ☒ **Wall**

infiltration @ barrel wall

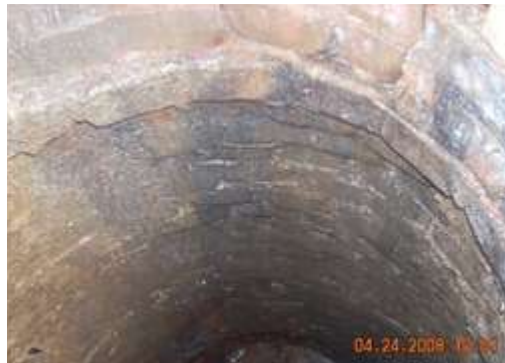
Defect 4

Infiltration: ☐ None ☐ Joint ☐ Cracks ☐ Mortar ☐ Roots ☒ **Wall**

infiltration @ corbel wall

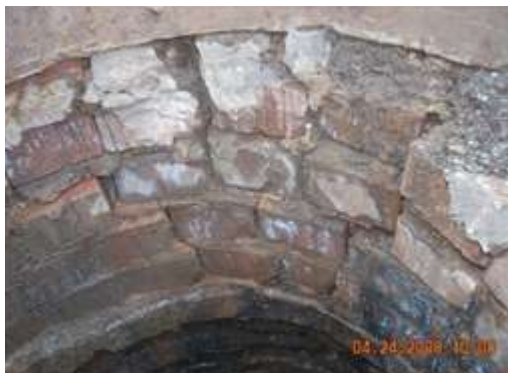
Defect 3

Condition: ☐ Sound ☐ Cracked ☐ Root Intrusion ☒ **Loose Brick** ☐ Deteriorated

loose corbel bricks

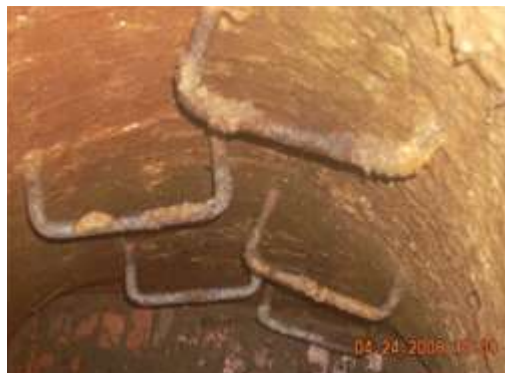
Defect 2

Steps Count: **5** Missing: **0** ☒ **Corroded**

corroded steps

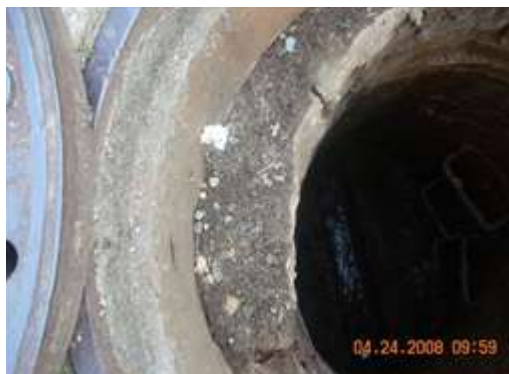
Defect 1

Frame Offset: **4** (in.) Condition: ☒ Sound ☐ Cracked ☐ Leaks

frame offset

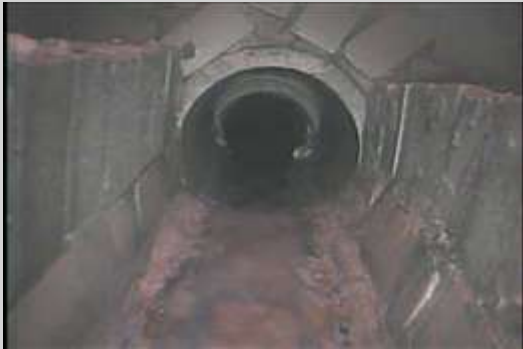
12 O'Clock Outflow

Pipe Height: **8.4** (in.) Rod and Bar (Angled)
Pipe Material: **Clay** ☐ Pipe Lined
Invert Depth: **10.09** (ft.) Flow Characteristics: **Slow**
Deposits: ☒ None ☐ Mud ☐ Sludge ☐ Debris ☐ Grease
Silt Depth: **0** (in.) Deposits Extent:
Infiltration: **None** Pipe Seal Cond: **Sound**

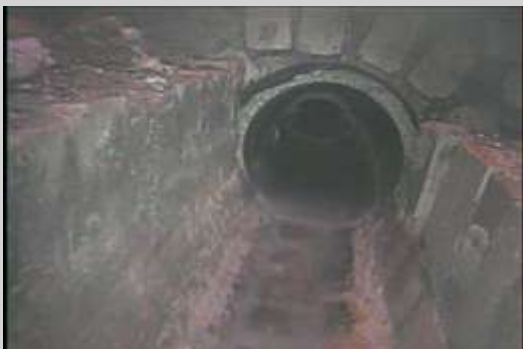
6 O'Clock Inflow

Pipe Height: **8.4** (in.) Rod and Bar (Angled)
Pipe Material: **Clay** ☐ Pipe Lined
Invert Depth: **10.05** (ft.) Flow Characteristics: **Slow**
Deposits: ☒ None ☐ Mud ☐ Sludge ☐ Debris ☐ Grease
Silt Depth: **0** (in.) Deposits Extent:
Infiltration: **None** Pipe Seal Cond: **Sound**
